**IN THE UNITED STATES DISTRICT COURT  
FOR THE WESTERN DISTRICT OF MISSOURI  
WESTERN DIVISION**

**CLASS ACTION COMPLAINT**

### **The Altima Floorboard Defect**

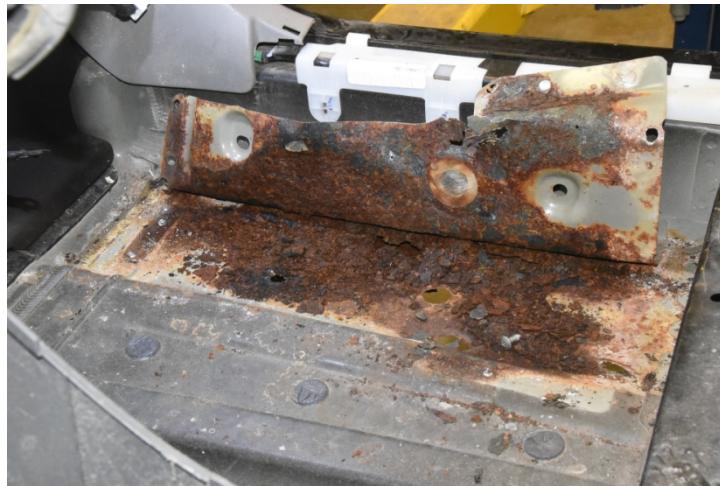
16. The Class Vehicles suffer from a Defect that prevents water from draining from the floorboard area of the vehicle and causes floor pans to corrode from the inside out. The

extent of the corrosion can be seen in the photographs reproduced below.<sup>6</sup>

18. The Altima floorboards have a concave design, which allows moisture to accumulate and remain in the affected area.

20. While there are multiple potential paths for moisture to enter the floorboards, the floorboards were designed with a hole through the middle metal layers—the member layer and the floorpan layer, approximately 1 inch in diameter. The floorboard holes are patched over with tape, rather than a watertight grommet or other watertight material. This patch extends just beyond the edges of the holes running through the metal layers. The member layer sits below the patch. This single patch is intended to cover both the member layer hole and floorpan layer hole, but the patch does not attach directly to the floorpan layer. Undercoating material sometimes covers these holes and the patching tape from underneath, but because there is no rigid material for the undercoating to bond to in the area of the hole, the undercoating fails to provide a long term watertight seal in this area. Additionally, vibration and any resulting contact between the floorpan layer and member layer causes wear to the painted coating, eventually exposing the metal layers to moisture and further resulting in accelerated corrosion of the floorboard. Water that enters through the compromised undercoating in the area of the holes, intrudes into the area between the two metal layers where the corrosion process appears to typically initiate and progress in a severe manner often resulting in complete perforation of the floorpan.

21. Nissan designed their defective floorboards with a metal member attached directly on top of the concave section of the floorboard by welds that join only the perimeter of the member to the floorboard. The combination of this layered design and the insufficiently patched holes in the metallic layers was a design defect that created the conditions for accelerated corrosion. The member isolates this concave region of the floorboard from the carpeted foot well, reducing the likelihood that any accumulated moisture could be wicked away from the metal floor pan by the carpeting or any padding material. Instead, a small gap exists between the top of the floorboard and underside of the member on top. The defective floorboard design thus

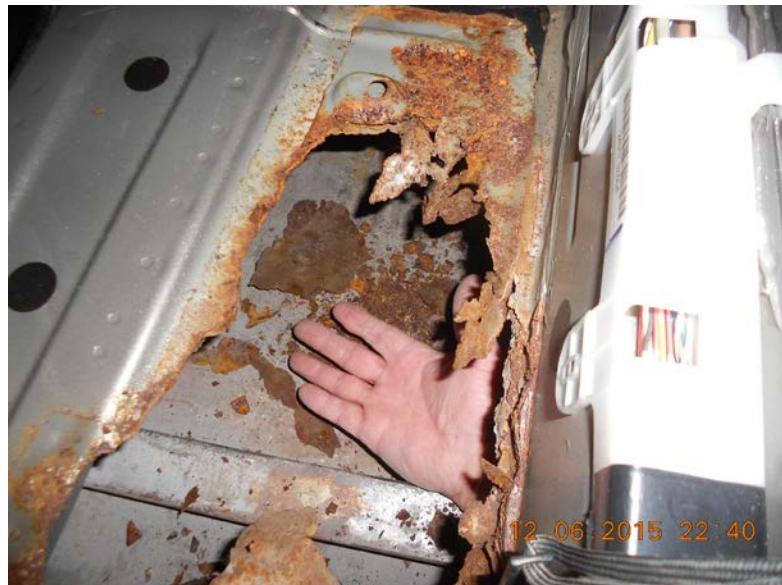
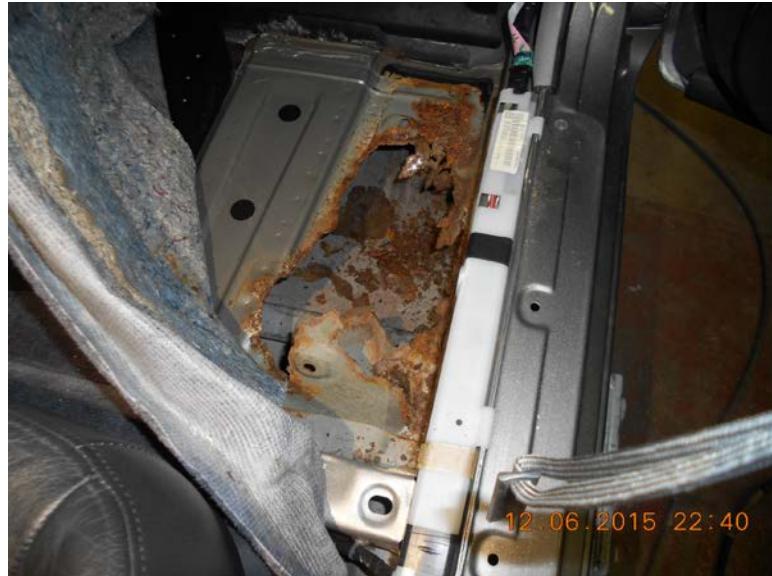
50. Plaintiff never noticed any problem with the floorboard in her vehicle. However, in early 2015, she viewed a news report regarding rust in Nissan Altima floorboards. An inspection revealed substantial rust under the front passenger floorboard; the following pictures reflect the rust in Plaintiff's floorboard:

52. Plaintiff received another estimate from Blue Springs Collision Repair ("BSCR") in February 2015; BSCR is a different automotive body repair shop located in Blue Springs, Missouri. The BSCR estimate was for a "patch" repair, meaning that it did not remove the rust and replace those affected parts, but merely covered the rusted area with sheet metal. The BSCR estimate was for \$459.00.

53. In December 2015, Plaintiff had BSCR apply its patch repair, and paid BSCR \$459.00 for the repair.
